# TECHNICAL SERVICE BULLETIN

## Cadillac Water Pump Installation Procedures – 4.1L, 4.5L and 4.9L (1985-1995)

CARTER PART NUMBER: W627M

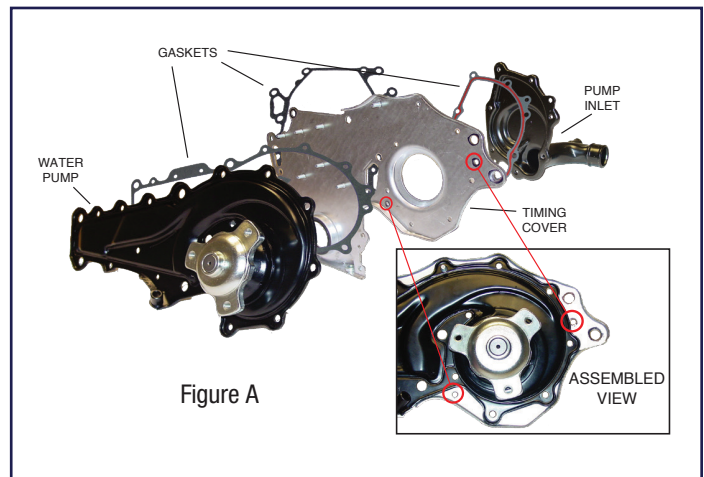
**CONDITION:** The inlet cover gasket, located between the timing cover and the inlet cover, shifts and causes a coolant leak that appears to be a leak from the water pump.

**CAUSE:** These particular Cadillac models' water pumps are tough to get to under the hood because of their tight location, and the pumps are secured with many fasteners. There are two bolts located very close to the outside edge of the water pump that must not be disturbed during the pump's replacement.

**CORRECTION:** Avoid unnecessary removal of these particular bolts when replacing the water pump. (See figure A)
