TECHNICAL SERVICE BULLETIN

Dodge Trucks & Jeeps Coolant Leak/Unnecessary Water Pump Replacement - 3.9L V6, 5.2L and 5.9L V8 (1993-2003)

CARTER PART NUMBER: W9126M

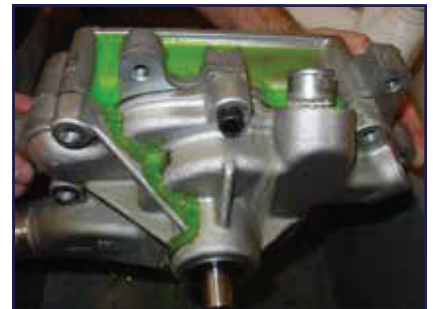
Figure 1

CONDITION: A coolant leak from a source above the water pump or from an improperly installed bypass tube on the water pump itself will cause coolant to pool on top of the timing cover. This coolant then rolls across the front of the pump and behind the pulley, making the pump appear to leak from the weep hole (**Figure 1**). This often results in unnecessary pump replacement.

CORRECTION: When replacing this pump, the supplied bypass tube should be installed with thread sealant and should be properly tightened before installation of the pump. The bypass hose and clamp should be inspected for wear, holes, or other flaws before they are reused and the area should be inspected for evidence of other leaks, such as from the thermostat housing. The original leak that prompted the pump to be changed may still be present and will need to be addressed.

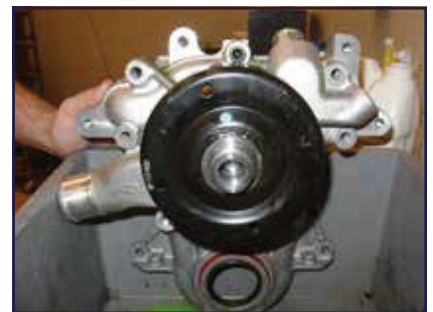
Figure 2

CAUSE: The pulley on this pump completely covers the face of the pump, making the correct diagnosis difficult (**Figure 2**). The bypass tube that is shipped loose in the box is often installed without sealant or is not tightened properly. The subsequent leak can cause antifreeze to gather on top of the timing cover, which is difficult to see. There are other components above the water pump, including the thermostat housing and the bypass hose, that can leak and cause antifreeze to gather in the same place and eventually mimic a leaking water pump.
