TECHNICAL SERVICE BULLETIN

General Motors Quad 4 Installation Advisory – 2.3L (1987-1995)

CARTER PART NUMBER: W721M

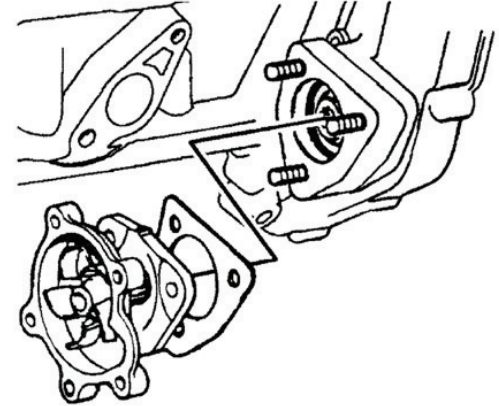
#1

CONDITION: The replacement water pump bearing is pressed downward as the mounting bolts are tightened, damaging the bearing.

CAUSE: Improper seating of the water pump bearing shaft into the bore in the timing chain idler bearing.

CORRECTION: To ensure proper installation, special attention must be paid to the proper seating of the splined end of the bearing shaft into the splined bore in the timing chain idler bearing.
