# TECHNICAL SERVICE BULLETIN

**2001-1996 Infinity, 2001-1995 Nissan w/VQ30DE 3.0L**

**2003-2001 Infinity, 2003-2001 Nissan w/VQ35DE 3.5L**

**CARTER PART NUMBER: W9122M**

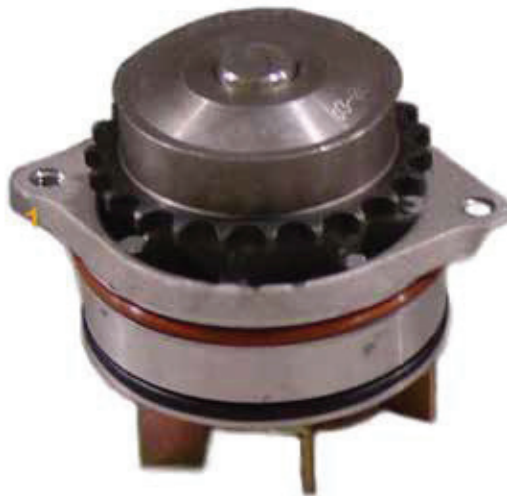
**CONDITION:** A severe coolant leak from the water pump's weep holes causes the coolant to destroy the pump's bearing, as well as leak into the engine's oiling system. **Catastrophic engine failure can result.**

**CAUSE:** This engine's water pump is buried beneath the timing cover since it is internally driven off the engine's timing chain. Since the front of the pump has direct contact with the engine's oiling system, the weep holes have been rerouted. Leaking coolant is channeled back through the pump and into the engine block. Therefore, if the water pump seal fails, the noticeable leaks will occur as coolant exits the left side of the engine block just below the thermostat housing.

**CORRECTION:** Be aware of the potential leak points and do not ignore the signs of a leak. It also is recommended that the water pump be changed whenever servicing the timing chain and/or internal timing components.
