TECHNICAL SERVICE BULLETIN

2003-2002 Infinity I35 3.5L & 2003-2002 Nissan Altima 3.5L

CARTER PART NUMBER: W9276M

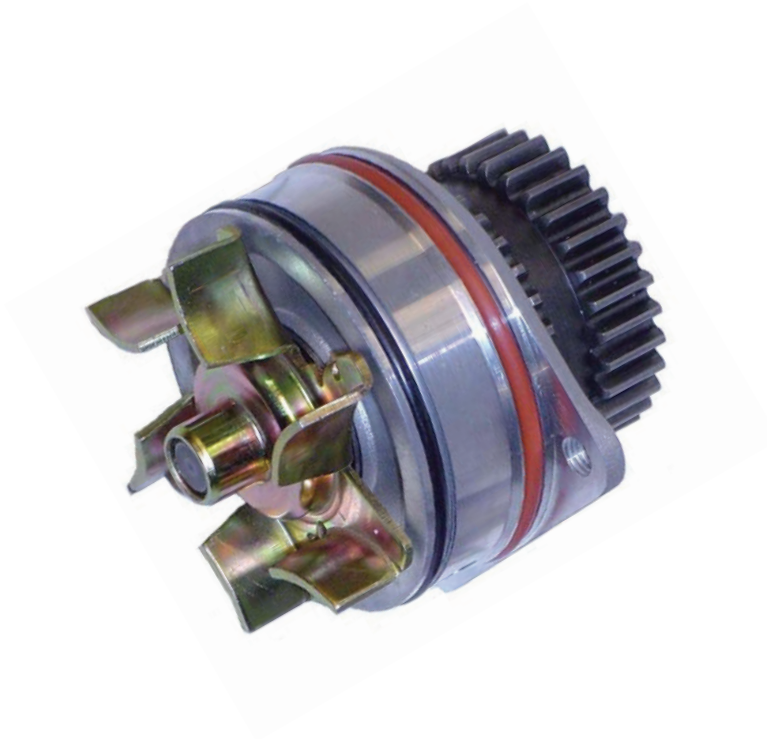
CONDITION: A severe coolant leak from the water pump's weep holes causes the coolant to destroy the pump's bearing, as well as leak into the engine's oiling system. **Catastrophic engine failure can result.**

CAUSE: This engine's water pump is buried beneath the timing cover since it is internally driven off the engine's timing chain. Since the front of the pump has direct contact with the engine's oiling system, the weep holes have been rerouted. Leaking coolant is channeled back through the pump and into the engine block. Therefore, if the water pump seal fails, the noticeable leaks will occur as coolant exits the left side of the engine block just below the thermostat housing.

CORRECTION: Be aware of the potential leak points and do not ignore the signs of a leak. It also is recommended that the water pump be changed whenever servicing the timing chain and/or internal timing components.
