TECHNICAL SERVICE BULLETIN

Mazda MVP Uses One of Two Different Water Pumps - V6 3.0L (1995-1996)

CARTER PART NUMBER(S): W764M & W9165M

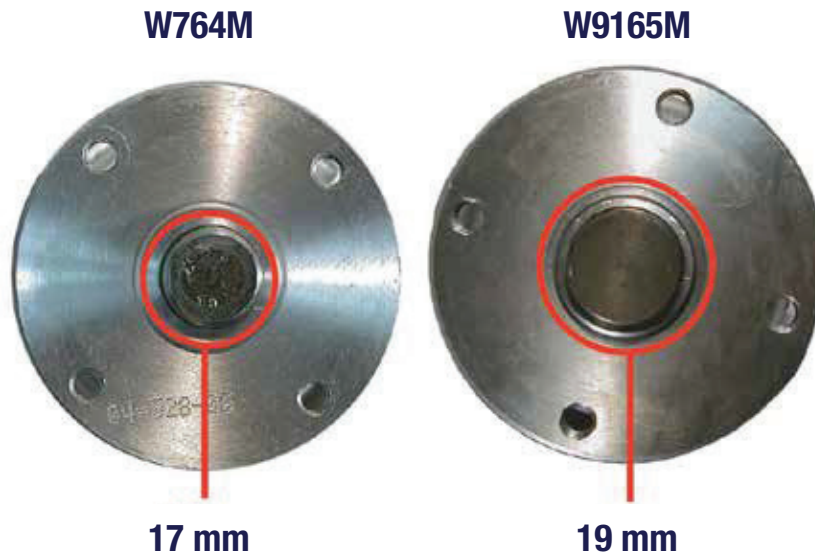
CONDITION: Installation of the incorrect water pump will make it impossible to install the fan clutch or allow the fan clutch to be tightened off center causing misalignment resulting in underhood part(s) damage.

CAUSE: The OE changed the fan clutch between model years where the vehicle could be equipped with either pump. The W764M's bearing shaft pilot for the fan clutch is 17 mm in diameter. W9165M's bearing shaft pilot for the fan clutch is 19 mm in diameter. The differences in diameter create the above conditions when installation is attempted using the incorrect pump.

CORRECTION: Double-check the water pump and fan clutch applications, paying specific attention to the production month. Also, verify that the fan clutch pilot and bearing shaft diameters match within 0.5 mm to be sure you are installing the correct water pump.
