TECHNICAL SERVICE BULLETIN

**2001-1996 Infinity, 2001-1995 Nissan w/VQ30DE 3.0L
2003-2001 Infinity, 2003-2001 Nissan w/VQ35DE 3.5L**

CARTER PART NUMBER: W9122M

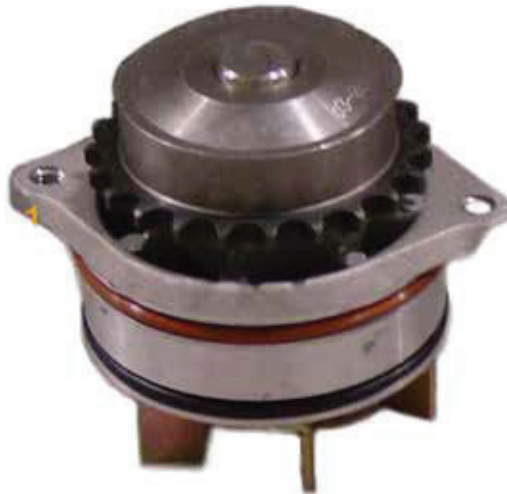
CONDITION: A severe coolant leak from the water pump's weep holes causes the coolant to destroy the pump's bearing, as well as leak into the engine's oiling system. **Catastrophic engine failure can result.**

CAUSE: This engine's water pump is buried beneath the timing cover since it is internally driven off the engine's timing chain. Since the front of the pump has direct contact with the engine's oiling system, the weep holes have been rerouted. Leaking coolant is channeled back through the pump and into the engine block. Therefore, if the water pump seal fails, the noticeable leaks will occur as coolant exits the left side of the engine block just below the thermostat housing.

CORRECTION: Be aware of the potential leak points and do not ignore the signs of a leak. It also is recommended that the water pump be changed whenever servicing the timing chain and/or internal timing components.
