# TECHNICAL SERVICE BULLETIN

## Tool Needed For Replacing Timing Chain Driven Water Pump on 2.0L, 2.2L and 2.4

**GM Engine:** Buick (2011-10); Chevrolet (2012-02); Chevrolet Truck (2012-10); GMC Truck (2012-10); Oldsmobile (2004-02); Pontiac (2010-02); Saab (2011-03); Saturn (2010-00)

**CARTER PART NUMBER: W9228M**

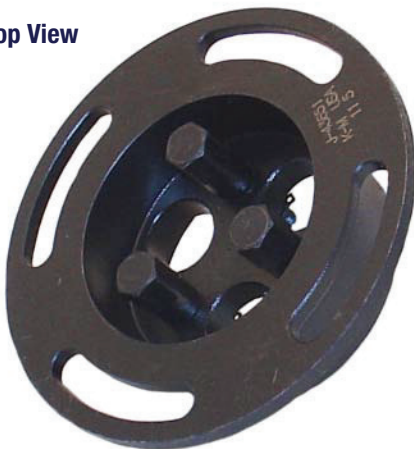
Top View

## Water Pump Sprocket Holding Tool

Remove the water pump access plate from the timing cover and install J 43651 Water Pump Sprocket Holding Tool; or equivalent. Follow manufacturer's water pump installation procedure.
