WHY DO WATER PUMPS FAIL?

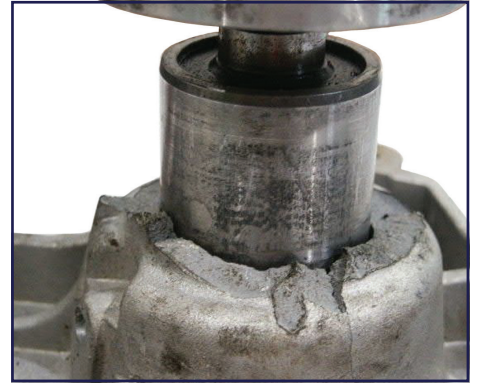
Casting Breakage 1

Cause: Excessive Vibration/Imbalance

- Breakage normally occurs around bearing support
- Result of vibration or imbalance resulting from a worn fan clutch or bent fan
- Tighten belts with a belt tensioner
- Check condition of fan/fan clutch
- Evenly tighten all mounting bolts

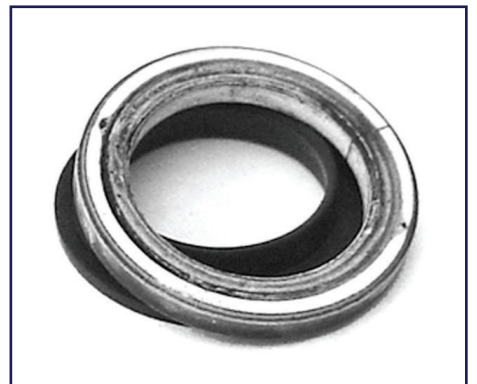
Thermal Shock to Seal

Cause: Adding Coolant to a Hot System

- No signs of contamination present
- Damage appears as a diametrical crack across seal face or mating ring
- Fill system with coolant before starting engine
- If overheated, allow engine to cool before filling system with coolant

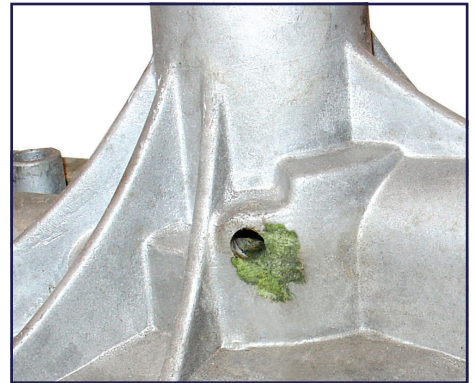
Normal Weep Stain

A small amount of weepage is expected during the normal operation of a water pump. The weepage is necessary to maintain lubrication of the seal faces.

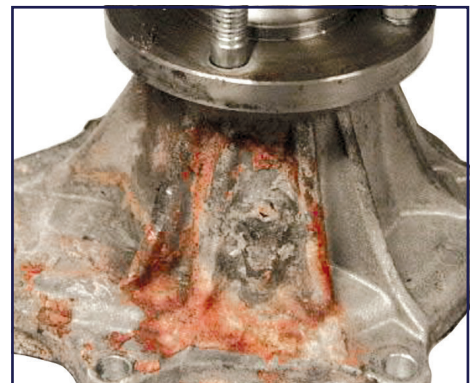
Leaking Pump

As a water pump seal begins to fail, coolant will flow from the weep hole at a much faster rate. This results in more visible staining, indicating the pump should be replaced. Left unattended, the excessive leakage will lead to bearing failure, complete pump failure and possible damage to related cooling system components.
