# TECHNICAL SERVICE BULLETIN

## Chrysler Concorde/Dodge Intrepid Coolant Leak – 2.7L (1998-2004)

**CARTER PART NUMBER: W9103M**

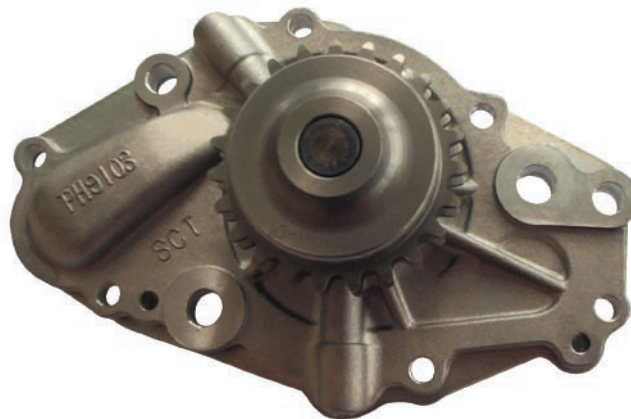
**CONDITION:** A severe coolant leak from the water pump's weep holes causes the coolant to destroy the pump's bearing, as well as leak into the engine's oiling system. **Catastrophic engine failure can result.**

**CAUSE:** This engine's water pump is buried beneath the timing cover since it is internally driven off the engine's timing chain. Since the front of the pump has direct contact with the engine's oiling system, the weep holes have been rerouted. Leaking coolant is channeled back through the pump and into the engine block. Therefore, if the water pump seal fails, the noticeable leaks will occur as coolant exits the left side of the engine block just below the thermostat housing and, if severe enough, from the rear of the engine block, towards the top.

**CORRECTION:** Be aware of the potential leak points and do not ignore the signs of a leak. It also is recommended that the water pump be changed whenever servicing the timing chain and/or internal timing components.
